Sand-Cement Concrete in the Century-Old Camarasa Dam

A. Blanco, Ph.D.¹; I. Segura, Ph.D.²; S. H. P. Cavalaro, Ph.D.³;
S. Chinchón-Payá, Ph.D.⁴; and A. Aguado, Ph.D.⁵

Author keywords: Sand-cement; Concrete dam; Freeze-thaw cycle; Leaching.

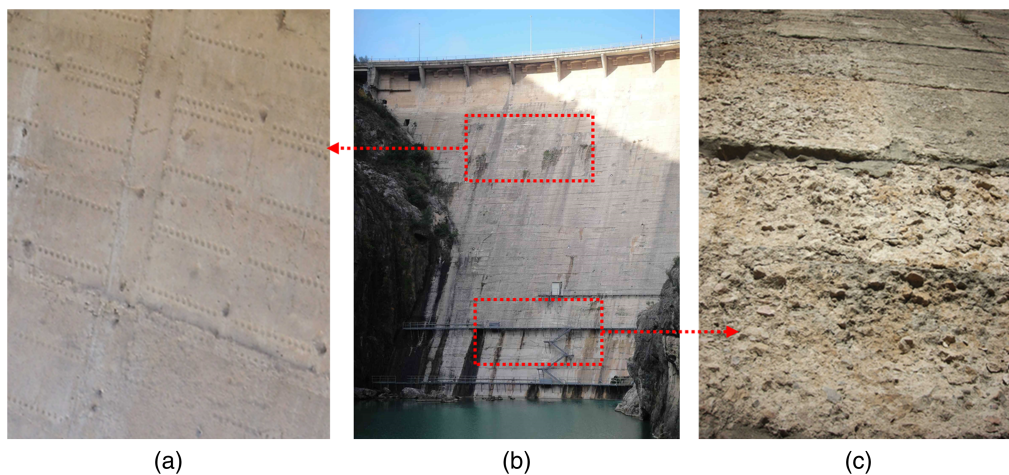
Regarding the state of the concrete in the downstream face [Fig. 1(a)], a partial degradation is observed in localized areas. The damage, characterized by the loss of mass [Fig. 1(b)], is located between 20 and 70% of the height of the dam. The deterioration was more evident in the right abutment and in the bottom area of the left abutment. The most feasible cause for the degradation is the mild freeze-thaw cycles, since there is loss of binder (in some areas even 15 cm), but the aggregates remain undamaged. This hypothesis is reinforced by the presence of water and the higher likelihood of sun-shadow cycles in the severely damaged areas. However, the upstream face presents a good state of conservation [Fig. 1(c)].

Fig. 1. Downstream face: (a) detail of higher areas; (b) general view; (c) detail of lower areas (reprinted from Conesa et al. 2015, with permission)

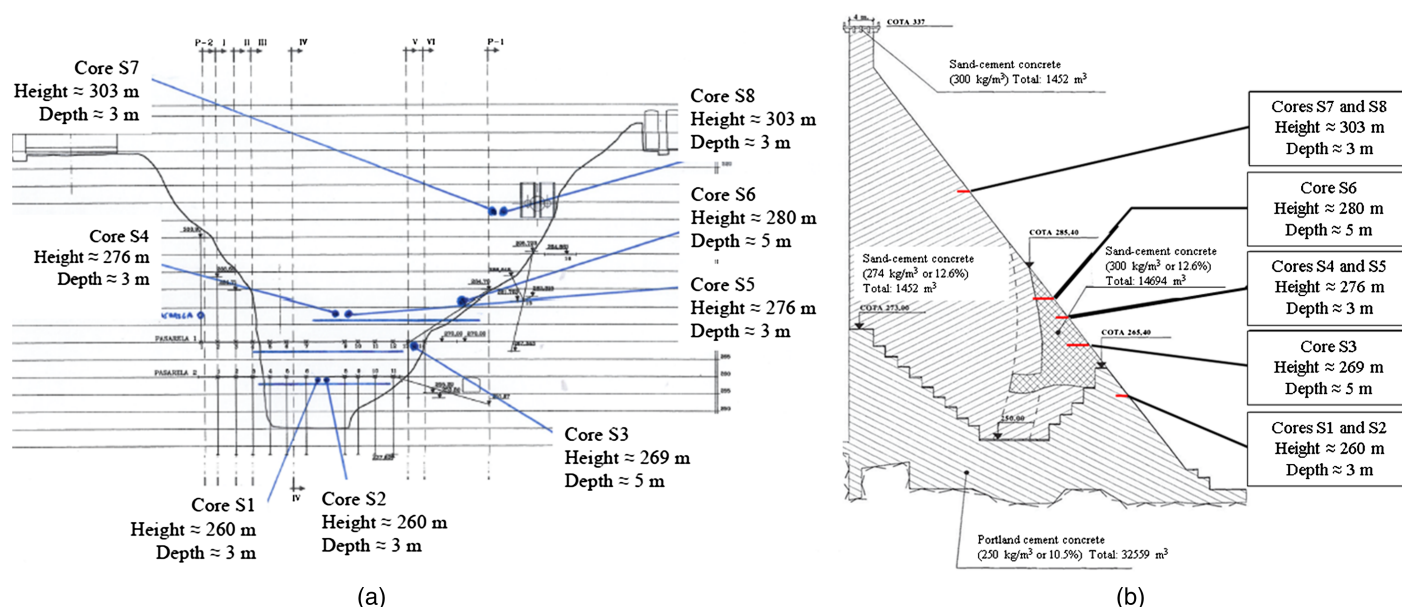
Fig. 2. Location of the cores in (a) downstream face; (b) lateral view (reprinted from ENDESA 2011, with permission)

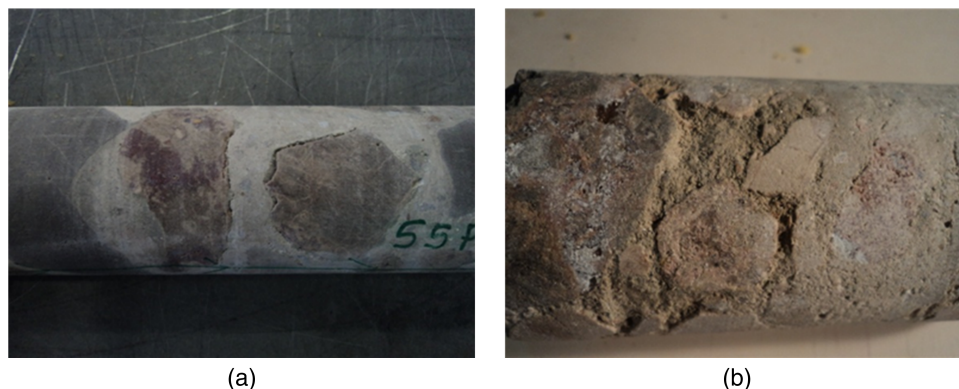
Visual inspection of the cores reveals that the cores extracted from the central area of the downstream face (cores S1, S2, S4, and S5) as well as the core S3 (extracted from the lower areas of the left abutment) exhibit a homogeneous aspect without significant signs of degradation. In some cases, a lack of bond in the aggregate-matrix interface was detected [Fig. 3(a)]. Furthermore, most of the cores exhibited aggregates with pores and cavities, some of which presented crystalline compounds.

The cores extracted from the left abutment of the dam at heights over 275 m (cores S6 and S8), showed more signs of degradation than others. Such degradation was caused by the lack of bond between the aggregate-matrix interface, cracking in the aggregates and the matrix, as well as cavities and green halos around certain aggregates.

Fig. 3. (a) Lack of bond between aggregate-matrix in S5; (b) deterioration in matrix of S8 (reprinted from Conesa et al. 2015, with permission)

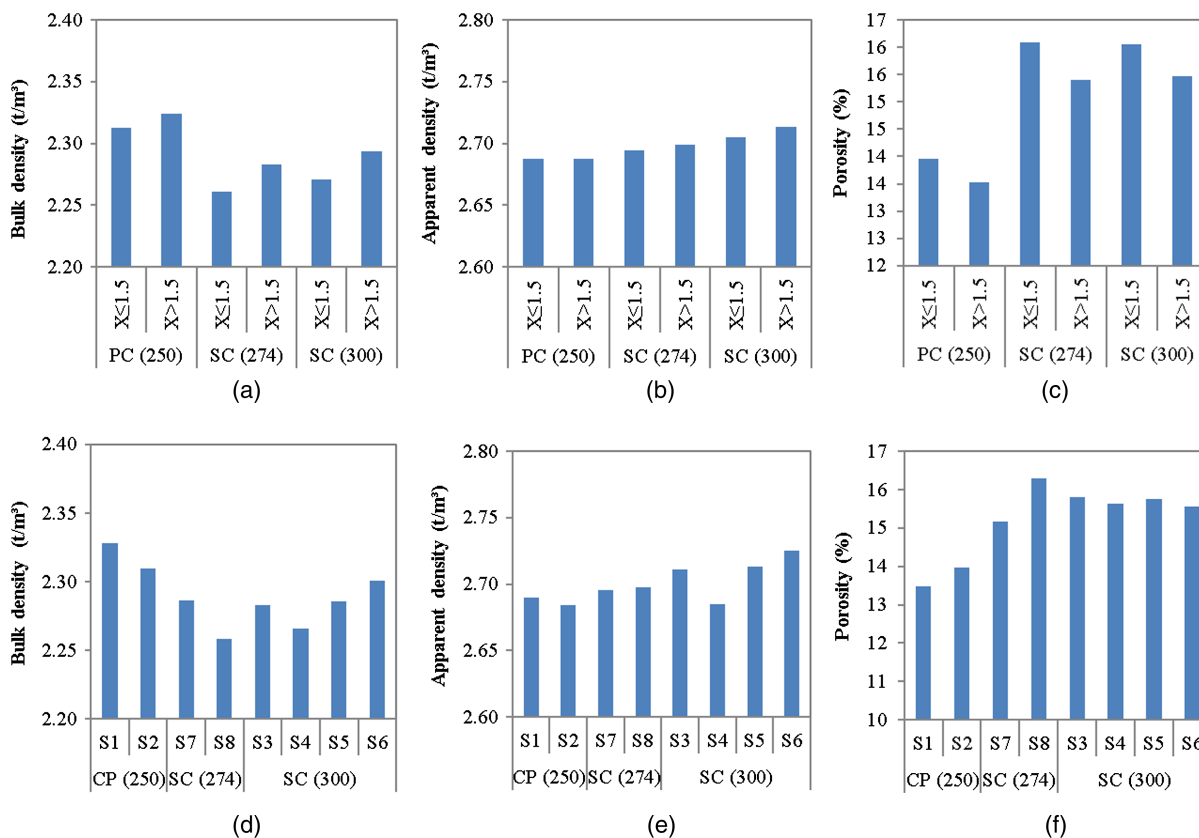
In general, the apparent density in the surface ($X \leq 1.5$ m) is lower than in the inside of the dam, particularly in the case of sand-cement [Fig. 4(a)]. However, no significant differences are observed in the real density with the depth, even though the scatter is smaller [Fig. 4(b)]. This outcome suggests the existence of a degradation process in the external part of the dam, which reduces the apparent density of the concrete. Since the variation does not occur for the real density, the origin of such degradation is unlikely to be chemical but physical. The damage is more evident in the concrete with sand-cement, which is consistent with the state of the downstream face.

The results in Fig. 4(c) verify the existence of a higher porosity in the superficial layers, which leads to the reduction of the apparent density in such areas. This variation may be attributed to the boundary conditions during the construction process or to the material degradation. The first hypothesis is discarded since the depth selected was large enough with respect to the dimension of the aggregate in order to avoid the influence of the construction process. Consequently, the most feasible hypothesis is superficial degradation.

Fig. 4. Variation with the depth: (a) bulk density (BD); (b) apparent density (AD); (c) porosity (P); variation for each core: (d) bulk density (BD); (e) apparent density (AD); (f) porosity (P)

The results of Fig. 4(f) corroborate the observations derived from the density analysis. Once more, the variations are not attributed to the location of the cores but rather to the composition of the concrete, i.e., the type of binder. Furthermore, smaller porosities were obtained for the concrete with portland cement [CP (250)]

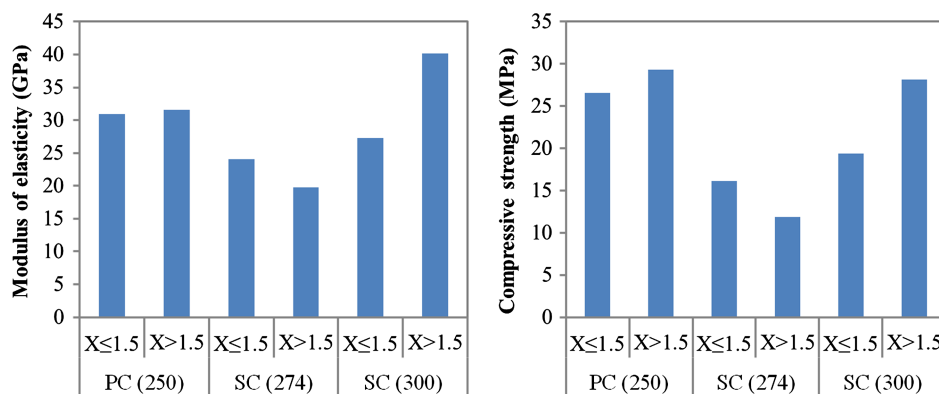
Fig. 5. Variation with the depth: (a) modulus of elasticity; (b) compressive strength

Fig. 5 presents the results of the modulus of elasticity and the compressive strength depending on the depth and the type of concrete. The values correspond to the average of the samples in the superficial areas and in the internal area. The dosages PC (250) and SC (300) exhibit an increase in the compressive strength in the internal layer, which is consistent with the results of density and porosity. Taking into account that the material should be

homogeneous in the studied zones, the variation observed may indicate a degradation process that is more evident for the sand-cement dosages than the portland cement dosages.

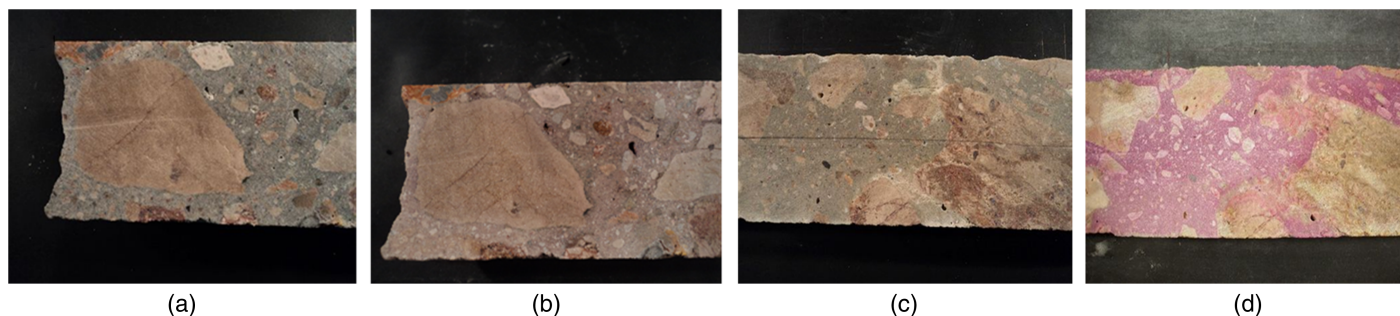
Fig. 6. Alizarin red-S staining in S1: (a) before staining; (b) after staining; universal pH staining in S3; (c) before staining; (d) after staining (reprinted from Conesa et al. 2015, with permission)

A similar situation occurs after analyzing the results of the pH universal staining. In general, a pink coloring was observed in the surface of most of the cores, which indicates a pH over 10 [Figs. 6(c and d)]. This outcome does not reveal a degradation of the material. The only areas where no coloring occurred were those that exhibited green halos.

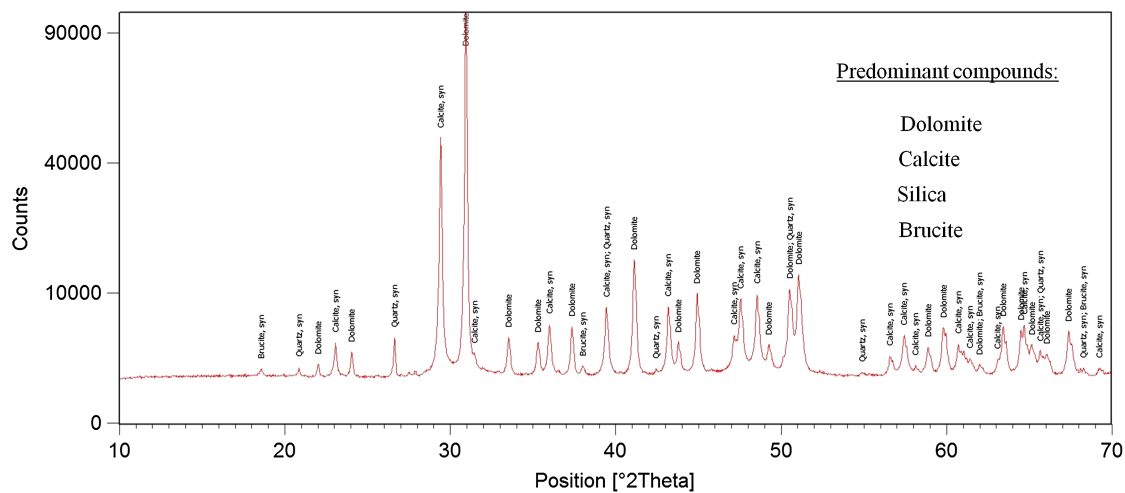
Fig. 7. XRD of the crystallization zone in core S3

shows the diffractogram obtained in a sample from core S3 and the predominant compounds found include dolomite, calcite, quartz, and a minor presence of brucite.

The remaining samples analyzed with XRD present similar results. Only a small amount of brucite was found, which is one of the main products of the dedolomitization reaction, and in such cases it was found in internal samples and never in the aggregate-matrix interface area. This phenomenon indicates that the brucite was already present in the aggregate before the concrete was produced.

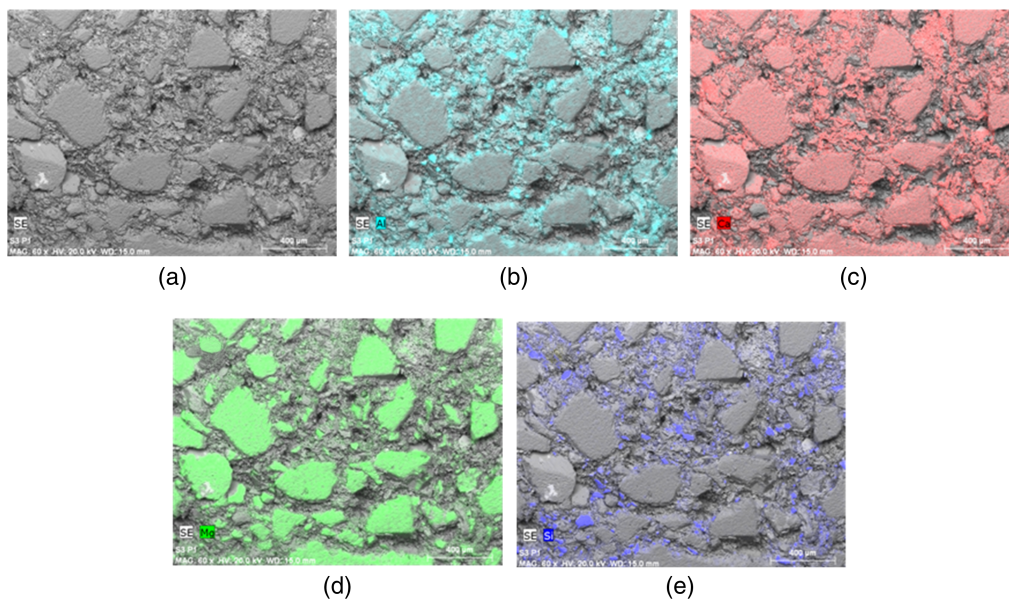
Fig. 8. Aggregate-matrix interface in a sample from core S3-zone 1: (a) SEM image; and maps by elements; (b) Al; (c) Ca; (d) Mg; (e) Si (reprinted from Conesa et al. 2015, with permission)

Even though Fig. 8 corresponds to a concrete with sand-cement, the content of Mg in the matrix is not high [Fig. 8(d)]. Instead, relatively large particles are found and a with low content in the matrix area. The aggregate-matrix interfaces do not reveal the existence of degradation phenomena. Likewise, the rest of the samples did not show evidence of degradation.
